ARM1020E Rev1 Errata List

Document number: ARM1020E REV1-PRDC-000685 7.0
Date of Issue: 24th June 2003
Author: Paul Garden
Authorised by: John Cornish

This document describes the known errata in the ARM1020E Rev1.

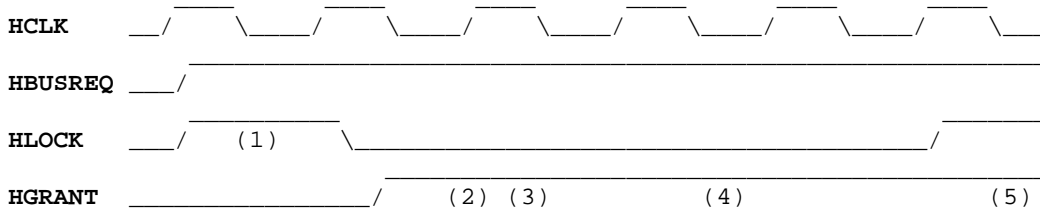
The following waveform shows the AHB signals to/from the arbiter. It is worth noting, that the compliance problem is solely related to the communication between the ARM1020E and the AHB arbiter. None of the address/control or data signals are involved.

- (1) HLOCK is erroneously asserted along with HBUSREQ for one HCLK cycle due to the pending swap instruction.
- (2) The AHB verifier complains, that HLOCK is removed before being granted via HGRANT!!!
- (3) The first store out of the Write-buffer takes place.
- (4) The second store out of the Write-buffer takes place.
- (5) The swap takes place as one locked (atomic) transfer.
