ARM1022E Rev0 Errata List

Document number: ARM1022E -PRDC-000705 12.0
Date of Issue: 24th June 2002
Author: Paul Garden
Authorised by: John Cornish

This document describes the known errata in the all ARM1022E revisions.

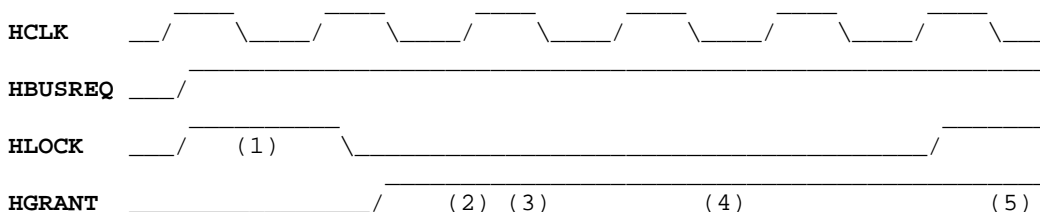
The following waveform shows the AHB signals to/from the arbiter. It is worth noting, that the compliance problem is solely related to the communication between the ARM1022E and the AHB arbiter. None of the address/control or data signals are involved.

- (1) HLOCK is erroneously asserted along with HBUSREQ for one HCLK cycle due to the pending swap instruction.
- (2) The AHB verifier complains, that HLOCK is removed before being granted via HGRANT!!!
- (3) The first store out of the Write-buffer takes place.
- (4) The second store out of the Write-buffer takes place.
- (5) The swap takes place as one locked (atomic) transfer.
