ARM920T Rev.1v4 Errata List

| Document number: | ARM920T-PRDC-000574 2.0 |
| Date of Issue: | 17 th December 2001 |

This document describes the known errata in the ARM920T Rev1 v4 design.

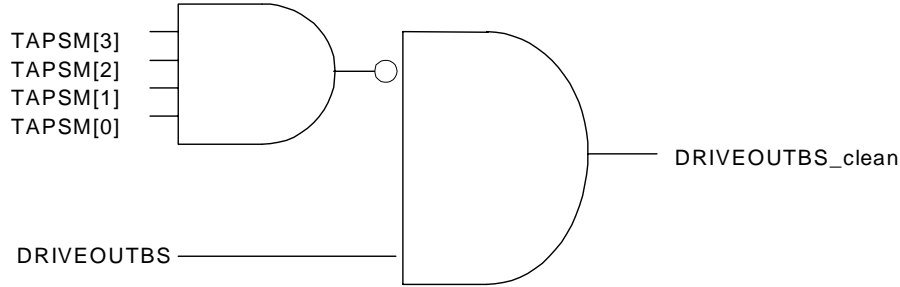
DRIVEOUTBS may be asserted incorrectly during a TAP controller reset.

If the JTAG TAP controller within the ARM9TDMI is reset, DRIVEOUTBS may be asserted incorrectly. If the DRIVEOUTBS signal is used to control the multiplexers in the scan cells of an external boundary scan chain then the boundary scan chain cells may be incorrectly controlled.

If the TAP controller state machine is made to enter the reset state by holding TMS high whilst its current instruction is INTEST, EXTEST, CLAMPZ or CLAMP then DRIVEOUTBS will be asserted for one TCK cycle. If the reset mechanism is nTRST then DRIVEOUTBS is driven correctly.

However during debug operation the TAP controller may be reset independently of a system reset. In this case, if TMS is used as the mechanism for causing the TAP controller to enter the reset state then DRIVEOUTBS will be incorrectly asserted. When DRIVEOUTBS is asserted the external scan chains will select the scan path and this could cause incorrect operation of the device.

The following external logic should be added to ensure correct operation of DRIVEOUTBS.

`DRIVEOUTBS_clean = (TAPSM != 4'b1111) & DRIVEOUTBS`

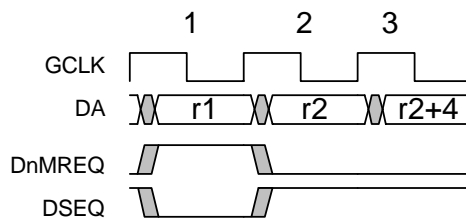
Example of a failing instruction sequence

A coprocessor memory transfer instruction (LDC or STC) can incorrectly have its first access (a non-sequential access) marked as being sequential.

For the first memory transfer of any memory instruction the ARM9TDMI should indicate on its data memory request signals that the transfer is non-sequential. This is indicated by DSEQ being low during this first memory access. However there is a particular situation for a LDC or STC instruction where its first memory transfer can incorrectly be marked as sequential. This case can only be invoked if a LDC or STC instruction, which fails its condition codes, is directly followed by a second LDC or STC instruction which passes its condition codes. For the precise conditions required see below.

During cycle (1) in the diagram above, the DnMREQ is high and DSEQ is low, indicating an IDLE cycle. This corresponds to the IDLE cycle generated by the LDC which fails its condition code check. In cycle (2) the first memory transfer for the second LDC occurs. In cycle DSEQ is incorrectly high, marking the transfer as being sequential.

If a coprocessor is attached with can execute LDC or STC instructions then this errata only applies if the coprocessor can execute an LDC or STC without busy-waiting the processor first. Thus a hardware workaround is to ensure all attached coprocessors insert a busy wait cycle before executing a LDC or STC.

A second work around is to ensure that the code does not contain a sequential instruction pair of LDC or STC instructions where it is possible for the first instruction to fail its condition code check and for the second to pass its condition code check.
