ARM940T Rev.2v2 Errata ListARM940T Rev.2v2 Errata List

Document number: ARM940T-PRDC-000610 2.0
Date of Issue: 17th December 2001
Author: Paul Garden
Authorized by: Jason Ackroyd

This document describes the known errata in the ARM940T Rev 2 v2 design.

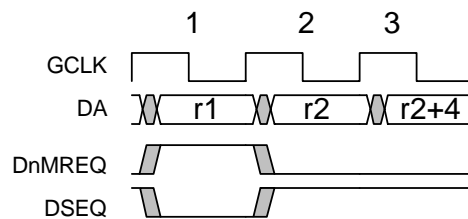
A coprocessor memory transfer instruction (LDC or STC) can incorrectly have its first access (a non-sequential access) marked as being sequential.

For the first memory transfer of any memory instruction the ARM9TDMI should indicate on its data memory request signals that the transfer is non-sequential. This is indicated by DSEQ being low during this first memory access. However there is a particular situation for a LDC or STC instruction where its first memory transfer can incorrectly be marked as sequential. This case can only be invoked if a LDC or STC instruction, which fails its condition codes, is directly followed by a second LDC or STC instruction which passes its condition codes. For the precise conditions required see below.

During cycle (1) in the diagram above, the DnMREQ is high and DSEQ is low, indicating an IDLE cycle. This corresponds to the IDLE cycle generated by the LDC which fails its condition code check. In cycle (2) the first memory transfer for the second LDC occurs. In cycle DSEQ is incorrectly high, marking the transfer as being sequential.

This errata only causes problems in systems with an externally attached coprocessor. If no coprocessors are attached, or no attached coprocessor can execute LDC or STC instructions then no work around is required.

If a coprocessor is attached with can execute LDC or STC instructions then this errata only applies if the coprocessor can execute an LDC or STC without busy-waiting the processor first. Thus a hardware workaround is to ensure all attached coprocessors insert a busy wait cycle before executing a LDC or STC.

A second work around is to ensure that the code does not contain a sequential instruction pair of LDC or STC instructions where it is possible for the first instruction to fail its condition code check and for the second to pass its condition code check.
