ARM9TDMI Rev 3 Errata ListARM9TDMI Rev3 Errata List

Document number: ARM9TDMI-PRDC-000577 1.0
Date of Issue: 2nd August 2001
Author: Ian Devereux
Authorised by: Simon Segars

This document describes the known errata in the ARM9TDMI Rev 3 design.

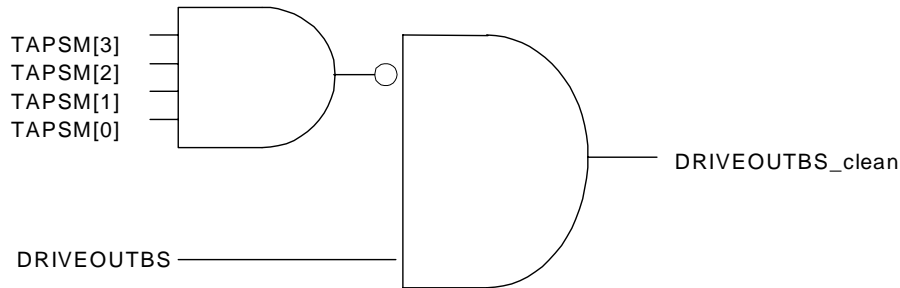
DRIVEOUTBS may be asserted incorrectly during a TAP controller reset.

If the JTAG TAP controller within the ARM9TDMI is reset, DRIVEOUTBS may be asserted incorrectly. If the DRIVEOUTBS signal is used to control the multiplexers in the scan cells of an external boundary scan chain then the boundary scan chain cells may be incorrectly controlled.

If the TAP controller state machine is made to enter the reset state by holding TMS high whilst its current instruction is INTEST, EXTEST, CLAMPZ or CLAMP then DRIVEOUTBS will be asserted for one TCK cycle. If the reset mechanism is nTRST then DRIVEOUTBS is driven correctly.

However during debug operation the TAP controller may be reset independently of a system reset. In this case, if TMS is used as the mechanism for causing the TAP controller to enter the reset state then DRIVEOUTBS will be incorrectly asserted. When DRIVEOUTBS is asserted the external scan chains will select the scan path and this could cause incorrect operation of the device.

The following external logic should be added to ensure correct operation of DRIVEOUTBS.

`DRIVEOUTBS_clean = (TAPSM != 4'b1111) & DRIVEOUTBS`

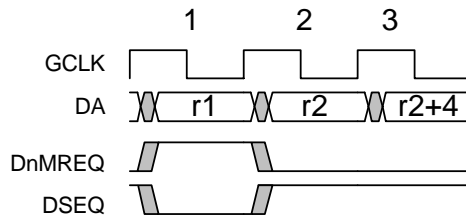
Example of a failing instruction sequence

A coprocessor memory transfer instruction (LDC or STC) can incorrectly have its first access (a non-sequential access) marked as being sequential.

For the first memory transfer of any memory instruction the ARM9TDMI should indicate on its data memory request signals that the transfer is non-sequential. This is indicated by DSEQ being low during this first memory access. However there is a particular situation for a LDC or STC instruction where its first memory transfer can incorrectly be marked as sequential. This case can only be invoked if a LDC or STC instruction, which fails its condition codes, is directly followed by a second LDC or STC instruction which passes its condition codes. For the precise conditions required see below.

During cycle (1) in the diagram above, the DnMREQ is high and DSEQ is low, indicating an IDLE cycle. This corresponds to the IDLE cycle generated by the LDC which fails its condition code check. In cycle (2) the first memory transfer for the second LDC occurs. In cycle DSEQ is incorrectly high, marking the transfer as being sequential.

If a coprocessor is attached with can execute LDC or STC instructions then this errata only applies if the coprocessor can execute an LDC or STC without busy-waiting the processor first. Thus a hardware workaround is to ensure all attached coprocessors insert a busy wait cycle before executing a LDC or STC.

A second work around is to ensure that the code does not contain a sequential instruction pair of LDC or STC instructions where it is possible for the first instruction to fail its condition code check and for the second to pass its condition code check.
