ARML210 Errata List

IP Products Division

Document number: AS006-PRDC-003350 14.0
Date of Issue: 3 February 2006
Author: Christophe Evrard
Authorised by: Peter Middleton

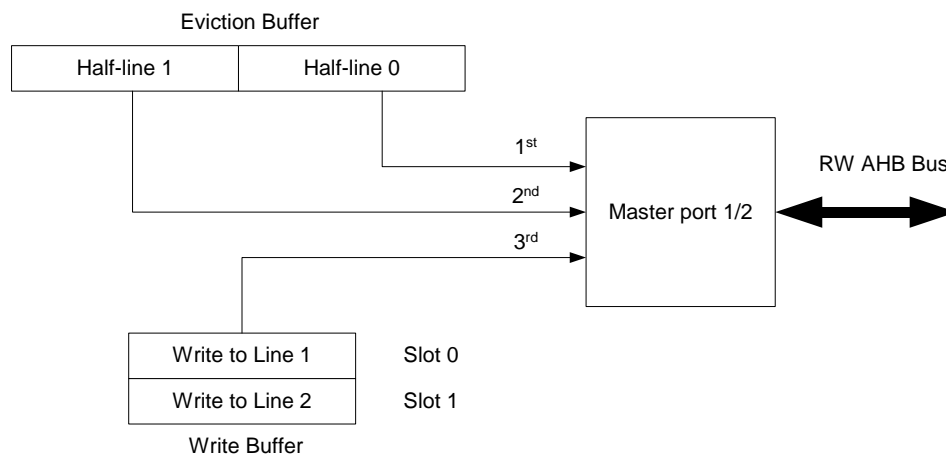
Figure 4-1 Expected order of eviction and write buffer draining

The figure below shows the normal order of write access to L3 memory system. The intended behaviour is that the eviction buffer is always empty when a write buffer slot is draining, so that any hazards between these two buffers are always naturally eliminated.

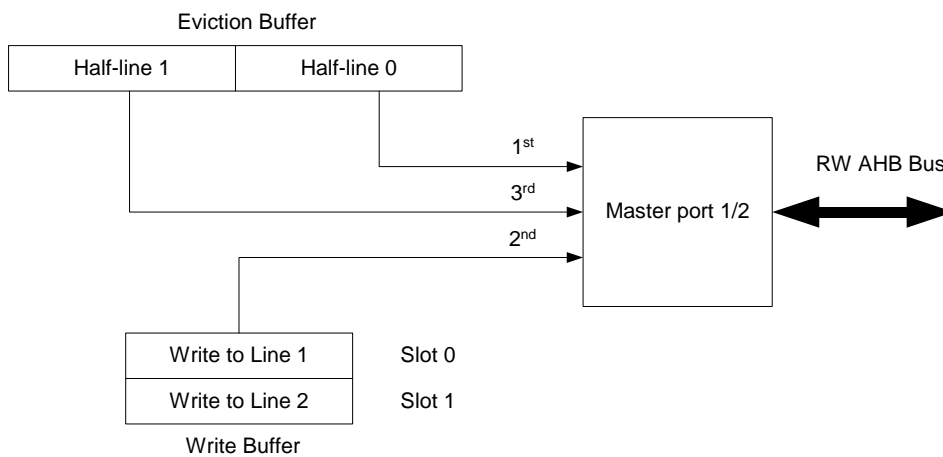
Figure 4-2 Faulty order of eviction and write buffer draining

A write buffer drain and an eviction to the same half cache line occurring at the same time can cause the L3 data to be overwritten with older value.

In the current case, the write buffer is actually taking ownership of the master port while a slot in the eviction buffer is still valid. Both slots of the eviction buffer are sharing the same request line to the master port and that request line wrongly goes low for one cycle once the first half eviction has been acknowledge by the master. That cycle gap is enough for the master to see that the next source in its priority list, the write buffer, is requesting access to the bus.

The result is that the L3 memory now contains the older data from the eviction buffer.

Data in L3 will be corrupted.

The work-around for this erratum is to use the L210 as a write-through cache only. When in write-through, all cache lines are always clean, so no evictions are ever performed when a cache line is replaced by a new allocation. From the software perspective, there are two ways to use L210 as a write-through cache:

1. Change memory regions attributes so that they are mapped as L2 write-through regions.
2. Set "Disable write-back" bit in ARM L210 Debug Control register (bit [1]). When that bit is set, all cacheable access are treated as write-through, allocate on read miss only in L2.
