## ARM Infrastructure PrimeCell AXI-AHB Bridges (BP137) **Errata Notice**

This document contains all errata known at the date of issue in releases up to and including revision r0p1 of AXIToAHB

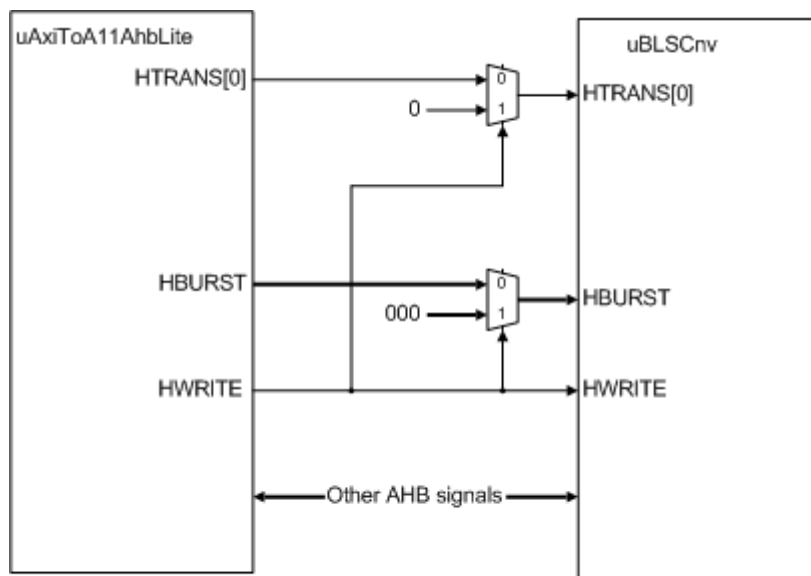
The issue arises when an AXI write transaction begins with an aligned, non-sparse write transfer but one or more subsequent write transfers in the same transaction are sparse. This causes the internal signal IHUNALIGN to transition from low to high at the output of the module AxiToA11AhbLite, as described in the Design Manual. When IHUNALIGN goes high, the byte lane strobe converter (BLScnv) converts each data transfer into series of byte transfers and the outputs HBURST, HTRANS, and HSIZE of BLScnv change. This violates the AHB protocol because the AHB transaction is mid-burst.

This breaks the AHB protocol, because HTRANS must not change from SEQ to NONSEQ, HBURST must not change from INCR8 to INCR, and HSIZE must not change from SIZE32 to SIZE8 until the first burst completes or is cancelled due to an error response.

Figure 1 Override HTRANS[0] and HBURST to uBLSCnv for write bursts

In AxiToAhbLiteM and AxiToAhbLiteS, override the HBURST input to the module uBLSCnv to SINGLE (3'b000) or INCR (3'b001), and override the HTRANS[0] input to the module uBLSCnv to LOW(1'b0) during write bursts. This is shown in Figure 1 below:

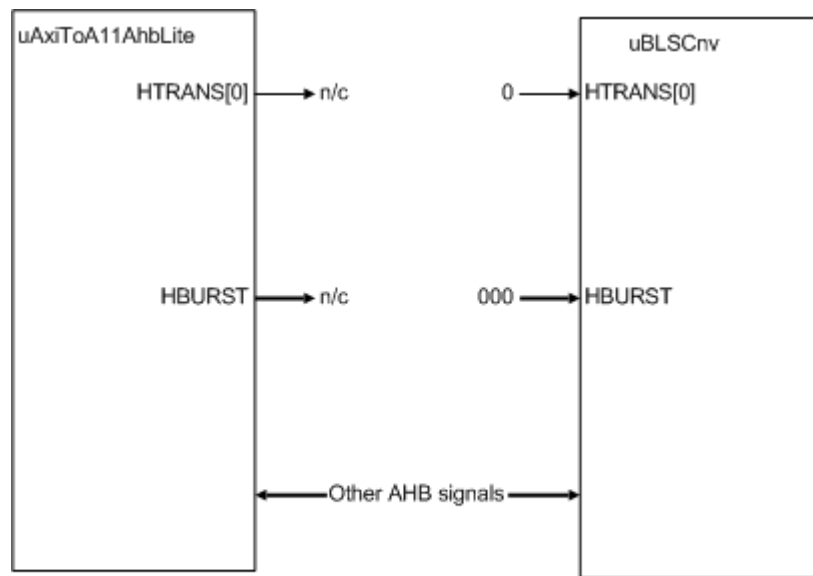
Figure 2 Permanently override HTRANS[0] and HBURST to uBLSCnv

A simpler version of this workaround is to ignore the direction of the burst and permanently override the HBURST and HTRANS[0] inputs to the module uBLSCnv. This has the disadvantage of potentially impairing performance during read bursts. This is shown in Figure 2 below:
