ARM ETM  
CoreSight™ ETM11™ (TM920)  
**Errata Notice**

This document contains all errata known at the date of issue in CoreSight ETM11 releases up to and including revision r1p1 of CoreSight ETM11.

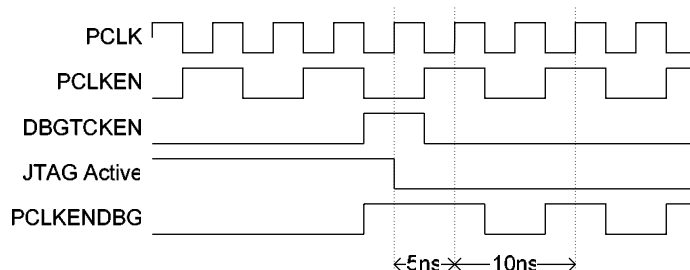
The ETMJTAGPORT in ETM11CSSingle generates PCLKENDBG as an APB clock-enable for the CoreSight ETM11. PCLKENDBG is driven from either PCLKEN (the system APB clock enable) or DBGTCEN from the JTAG synchronising logic in ETM11CSSingle. When the ETMJTAGPORT switches from JTAG to system APB or from system APB to JTAG, the PCLKENDBG input to the CoreSight ETM11 might cause consecutive PCLKENDBG pulses to be closer than synthesis constraints allow.

For example, consider if PCLK is driven at 200MHz and PCLKEN is used to produce an effective system APB clock speed of 100MHz. The time between 2 rising PCLK edges where PCLKEN is high is 10ns. If the ETMJTAGPORT switches while PCLKEN is low, then the time between 2 rising PCLK edges where PCLKENDBG is high might be 5ns. This might violate timing constraints. The timing diagram below shows how PCLKENDBG might behave.
