ARM ETM
CoreSight™ ETM9™ r0 (TM910)
Errata Notice

This document contains all errata known at the date of issue in CoreSight ETM9 r0 releases up to and including revision r0p1 of CoreSight ETM9

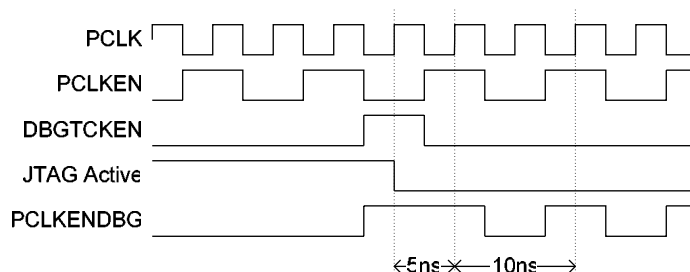
439043: PCLKEN input to ETM9CSSingle might cause timing closure failures

The ETMJTAGPORT in ETM9CSSingle generates PCLKENDBG as an APB clock-enable for the CoreSight ETM9. PCLKENDBG is driven from either PCLKEN (the system APB clock enable) or DBGTCEN from the JTAG synchronising logic in ETM9CSSingle. When the ETMJTAGPORT switches from JTAG to system APB or from system APB to JTAG, the PCLKENDBG input to the CoreSight ETM9 might cause consecutive PCLKENDBG pulses to be closer than synthesis constraints allow.

For example, consider if PCLK is driven at 200MHz and PCLKEN is used to produce an effective system APB clock speed of 100MHz. The time between 2 rising PCLK edges where PCLKEN is high is 10ns. If the ETMJTAGPORT switches while PCLKEN is low, then the time between 2 rising PCLK edges where PCLKENDBG is high might be 5ns. This might violate timing constraints. The timing diagram below shows how PCLKENDBG might behave

Timing constraints might be violated. This might result in failure to achieve timing closure. This is not expected to cause significant functional problems because the signals which are sampled using PCLK and PCLKENDBG in the CoreSight ETM9 will not be changing around the switching point under normal circumstances.
