ETB Rev0 Errata List

CPU Cores Division

Document number: **ETB-PRDC-001103 17.0**
Date of Issue: 11 February 2011
Author: ARM

This document describes the known errata in the Embedded Trace Buffer design.

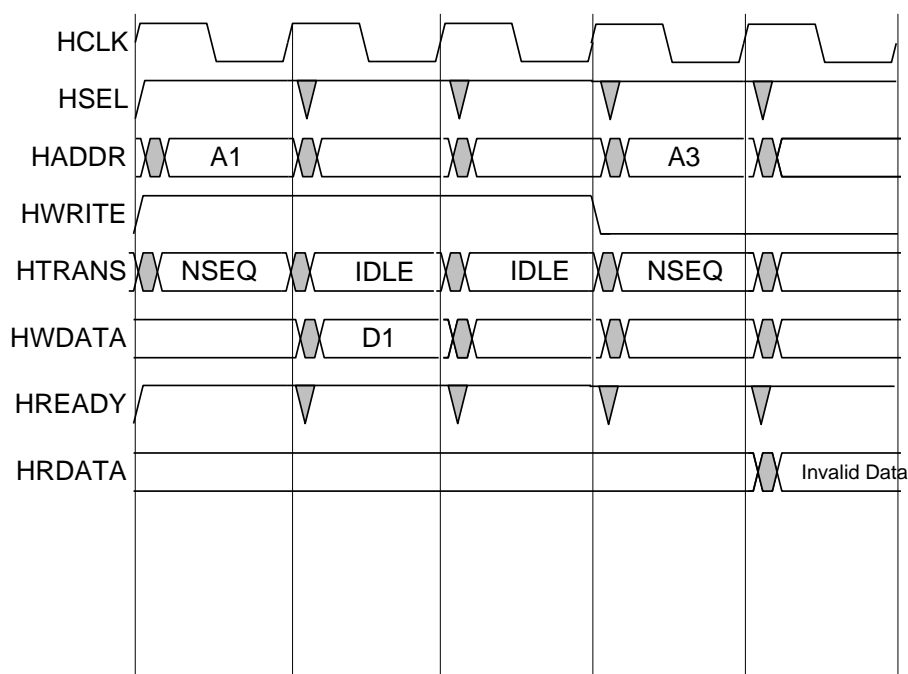
Figure 1: Waveform Diagram

During an AHB transfer, if an IDLE transfer with HWRITE HIGH is made to the ETB RAM, then an ETB RAM read directly following this transfer will be invalid. An undefined value is written to the intended RAM read address and the returned read value is undefined.

HWRITE must be high during the AHB IDLE cycle with the ETB selected. This is usually because HWRITE is held at its last value between AHB transfers. If HWRITE is driven low during AHB IDLE cycles, this erratum does not occur.

An undefined data value is written to the intended RAM read location and the returned read value is undefined.

There are no known workarounds for this erratum in existing designs. For new designs, this erratum can be avoided by using the ETB in asynchronous mode (by tying **SBYPASS** to 0).

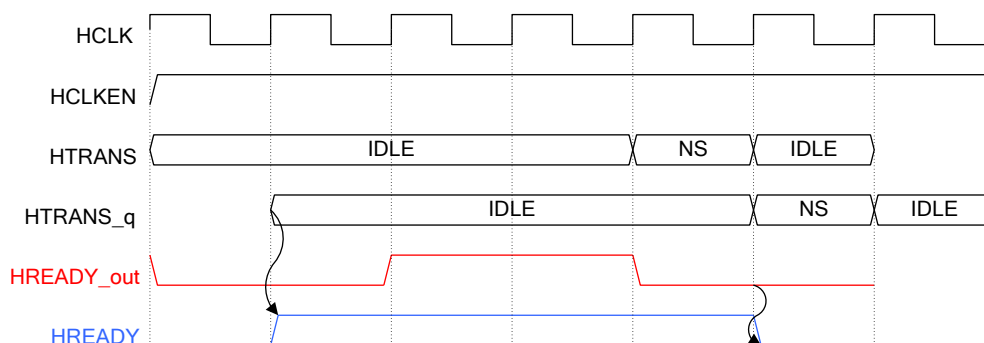
The AMBA AHB specification requires that a slave must respond to an IDLE or BUSY transaction with a zero wait-state OK response. The ETB might not always respond with a zero wait-state OK response to IDLE or BUSY transactions.

The HREADY output from the ETB might be driven low during the data phase of the IDLE or BUSY transaction.

The AHB master driving the ETB might assume that IDLE or BUSY transactions will always result in a zero wait-state response. This erratum might cause the AHB master to drive a new NSEQ or SEQ transaction on the AHB interface while HREADY is low and therefore causing the ETB to miss the new transaction.

The HREADY output from the ETB must be qualified based on whether an IDLE or BUSY transaction is in progress. It is important that this is done during the data phase of the transfer (second cycle) and therefore a registered version of HTRANS[1] should be used. While this registered version of HTRANS[1] is b0 HREADY must be high. This is shown in the following timing diagram example illustrating an IDLE transaction:

This can be achieved with the following logic applied to HREADY output from the ETB creating a new HREADY output.
