**ARM ETM
ETB11 (TM070)
Errata Notice**

This document contains all errata known at the date of issue in releases up to and including revision r0p1 of Embedded Trace Buffer for ETM11 (ETB11)

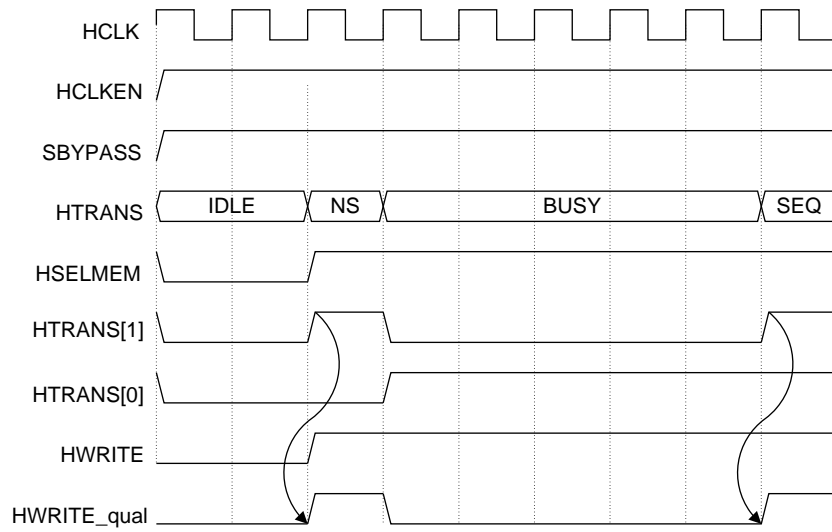
The AMBA AHB specifications allow a master to insert BUSY cycles during a burst transfer. An attempt to write to the ETB11 via AHB while HTRANS is set to BUSY for at least 5 cycles will corrupt location 0x0 in the ETB11 RAM.

The HWRITE signal must be qualified by HTRANS[1] before being connected to the ETB11.

```
assign HWRITE_qual = HWRITE & HTRANS[1]
```

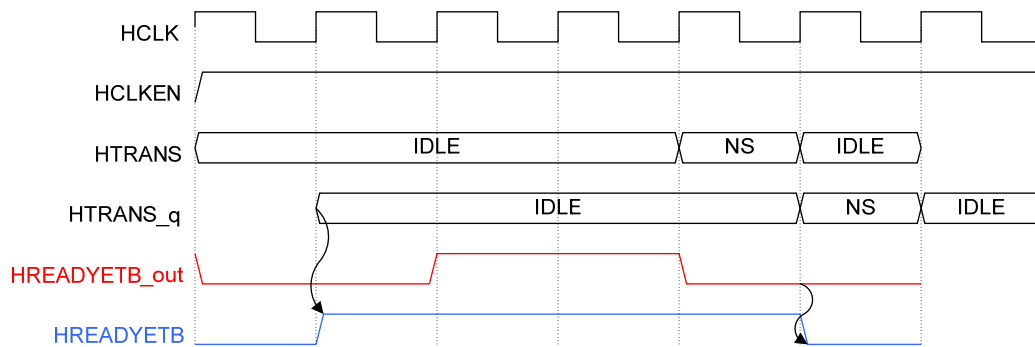
The AMBA AHB specification requires that a slave must respond to an IDLE transaction with a zero wait-state OK response. The ETB11 might not always respond with a zero wait-state OK response to IDLE transactions.

The HREADYMEM output from the ETB11 will unexpectedly be driven low during the data phase of the IDLE transaction, dependent on a certain internal state of the ETB11.

The HREADYETB output from the ETB11 must be qualified based on whether an IDLE transaction is in progress. It is important that this is done during the data phase of the transfer (second cycle) and therefore a registered version of HTRANS should be used. While this registered version of HTRANS is b00 HREADYETB must be high.

This can be achieved with the following logic applied to HREADYETB output from the ETB11 creating a new HREADY output.
