ARM
L220 Level 2 Cache Controller (AC131)
Errata Notice

This document contains all errata known at the date of issue in releases up to and including revision r1p7 of L220

Date of Issue: March 13, 2009

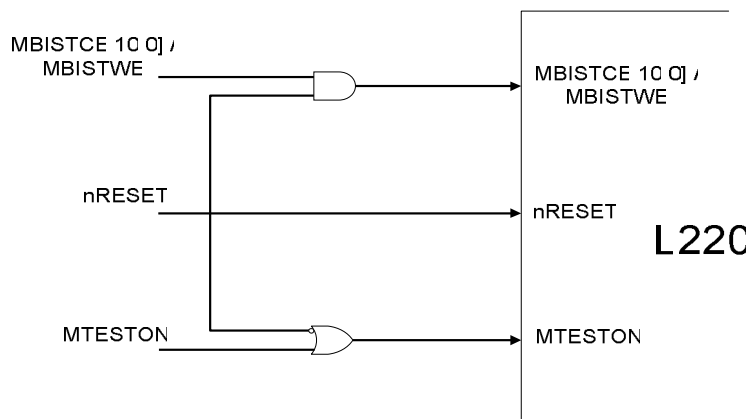
Figure 1: Implementation workaround for 401552 erratum when the L220 MBIST interface is used

The registers mbist_ce_reg[10:0] and mbist_we_reg declared in the L220_bist_if.v verilog file are not reset. As a result, they have an unknown value (1'bX in simulation, VDD or VSS on silicon) after the L220 cache controller has been reset. However, the output of these registers is used to control some RAM output signals in L220_cache_ctl.v, even if the MBIST mode is not enabled (i.e. in functional mode).

On silicon, the value of uninitialised registers is unpredictable. If the output of the mbist_ce_reg[10:0] and mbist_we_reg registers is not VSS when the power is turned on, failures (incorrect values driven to the RAMs) occur in functional mode. Under these circumstances, this means that L220 cannot be enabled.

There is one possible workaround for this erratum. Before L220 is enabled, e.g. during the reset sequence of L220 (nRESET asserted LOW), MTESTON can be driven HIGH for at least one clock cycle while MBISTCE[10:0] and MBISTWE are driven LOW. This allows propagating known and inactive values to the output of the mbist_ce_reg[10:0] and mbist_we_reg registers.

- if the L220 MBIST interface is used

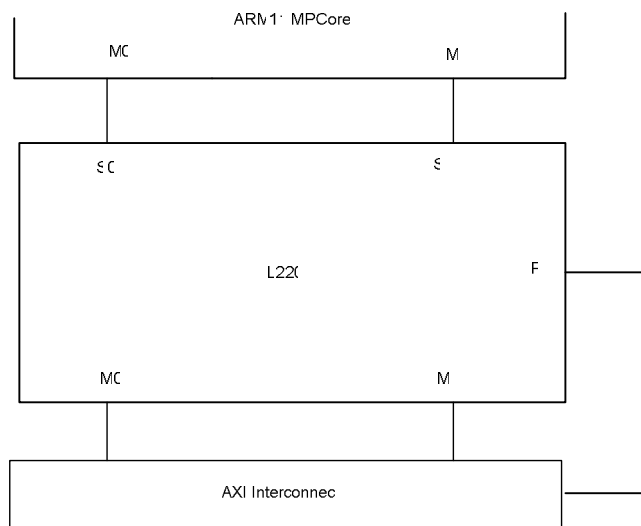
Under the conditions listed above, a deadlock occurs.

If the system connectivity is exactly as described in the figure below (note the M0 → S0 and M1 → S1 connections between ARM11 MPCore and L220 and the 2slaves/2masters configuration for L220),

then a workaround for this erratum is to run the following pseudocode sequence to launch the maintenance operations:

- Replace the Cache Sync operation by a dummy SWP to a cacheable or non-cacheable memory area that will go through one of the two main L220 slave ports (S0 or S1). The AXI locked transactions received by the L220 slave ports are only treated once all buffers are empty, thus acting like a Cache Sync. This dummy SWP must not target the L220 Peripheral port, see erratum 533267 for more information.
- Replace the Clean and/or Invalidate by PA or Index/Way operations by Clean and/or Invalidate by Way operations.

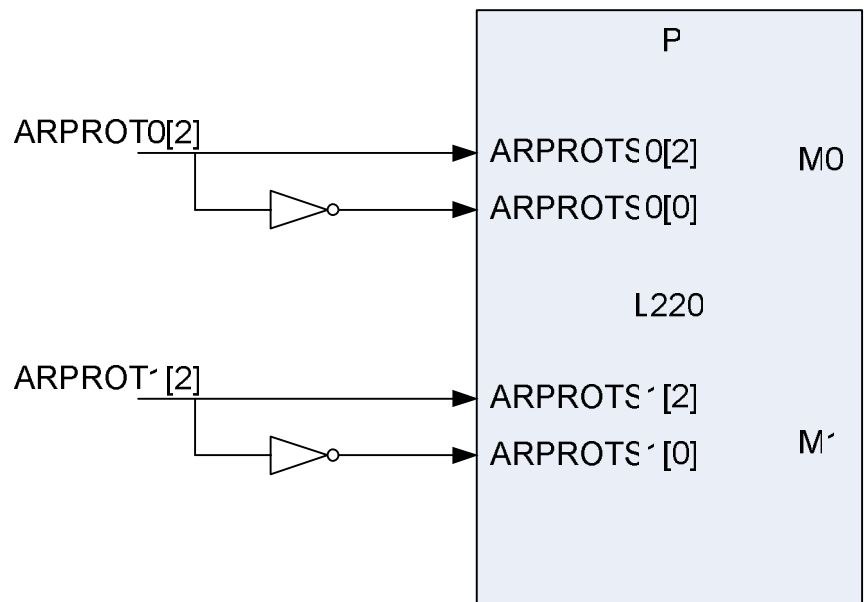
**Figure 3: Implementation workaround for 391290 erratum**

There is no software workaround for this erratum.

There is a possible implementation workaround for this erratum. Indeed, ARPROT[0] indicates if the read transaction is normal or privileged. This information is not used within L220 and can only be relied upon at L3 level in case of Strongly Ordered or Device accesses. If ARPROT[0] is not used by the L3 memory system in that context, it is possible to workaround the erratum described above by connecting ARPROT[2] to the ARPROT[0] input on the L220 slave ports, as described in the figure below.
