# ARM720T r4pN Errata List

Document number: ARM720T-PRDC-003802 4.0  
Date of Issue: 20 March 2009

This document describes the known errata in the ARM720T r4p3 design.

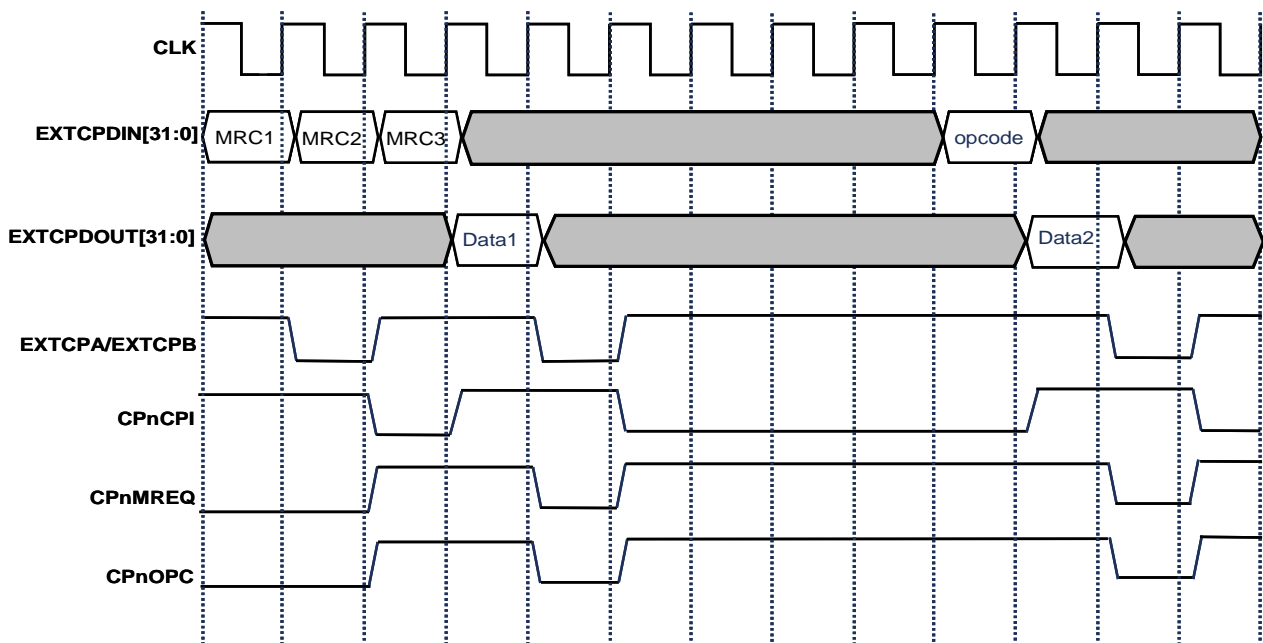
Figure 1, shows how EXTCPA/EXTCPB are driven in the AVS testbench, causing the bug not to trigger.

Fig 1: EXTCPA/EXTCPB as driven in the AVS testbench

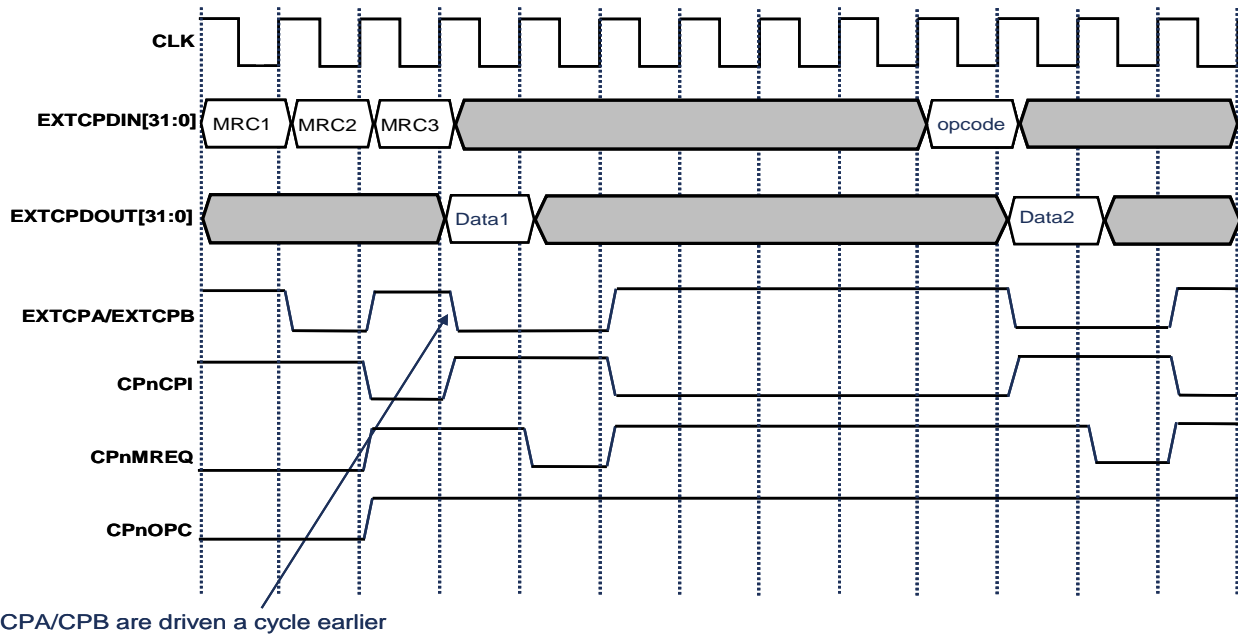
If two or more MRC instructions are fetched sequentially, the second and any subsequent MRC instructions may not be correctly executed by the core.

The bug is only encountered if the value of <opcode\_1> is set to 3'bx1x and only if EXTCPA/EXTCPB are being driven low by the coprocessor a cycle earlier with respect to CPnOPC/CPnMREQ going low. The bug only affects external coprocessor accesses and not internal CP15 operations.

Figure 2, shows how the bug is triggered, e.g. when EXTCPA/EXTCPB are driven a cycle earlier by the coprocessor.

Fig 2: EXTCPA/EXTCPB driven a cycle earlier

- 1: Delay EXTCPA/EXTCPB inputs by a full clock cycle, e.g. so that they are taken low when CPnOPC/CPnMREQ go low.
- 2: Insert a NOP instruction between each MRC instruction that appear in program code, there will be an overhead of an additional instruction for each sequential MRC instruction fetched and executed by the core.
