# ARM7TDMI-S Errata List

Document number: FR002-PRDC-002719 7.0

Date of Issue: 20<sup>th</sup> March 2009

This document describes the known errata of releases rev2, rev3, rev3a, rev4p0-p2 and rev4p3 of the ARM7TDMI-S design.

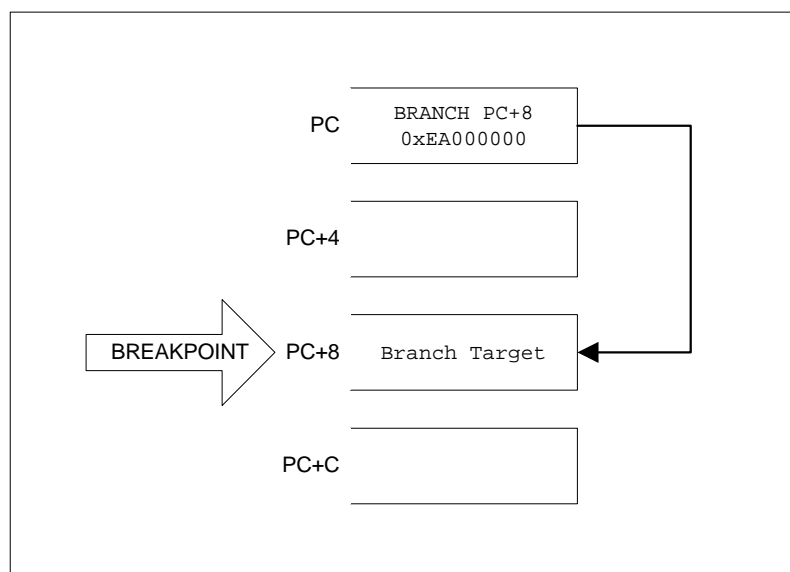
This case only affects the Branches to pc+8 in ARM State, and Branches to pc+4 in Thumb State. Other branch instructions are unaffected. The problem will only be encountered if the Branch is taken. If the branch is not taken, the breakpoint will be taken correctly. This branch could either be caused by an explicit branch instruction, or an instruction, which directly changes the PC, such as MOV PC, or LDR PC.

If a breakpoint is set on the destination of a branch to pc+8 (or pc+4 in Thumb State) the breakpoint will be ignored by the ARM7TDMI-S. This is due to the breakpointed instruction being fetched twice in consecutive cycles. The first is prefetch beyond the branch, and is discarded. The second is to re-fill the pipeline and is executed. The second breakpoint is not flagged correctly and the breakpoint is ignored. See diagram below.

With the current tools release users should be aware of this issue. If they suspect that a breakpoint has not been taken, they should set a breakpoint on the following instruction instead. When single stepping users should be aware that a branch to pc+8 cannot be single stepped, and place a breakpoint on the instruction following the branch target.

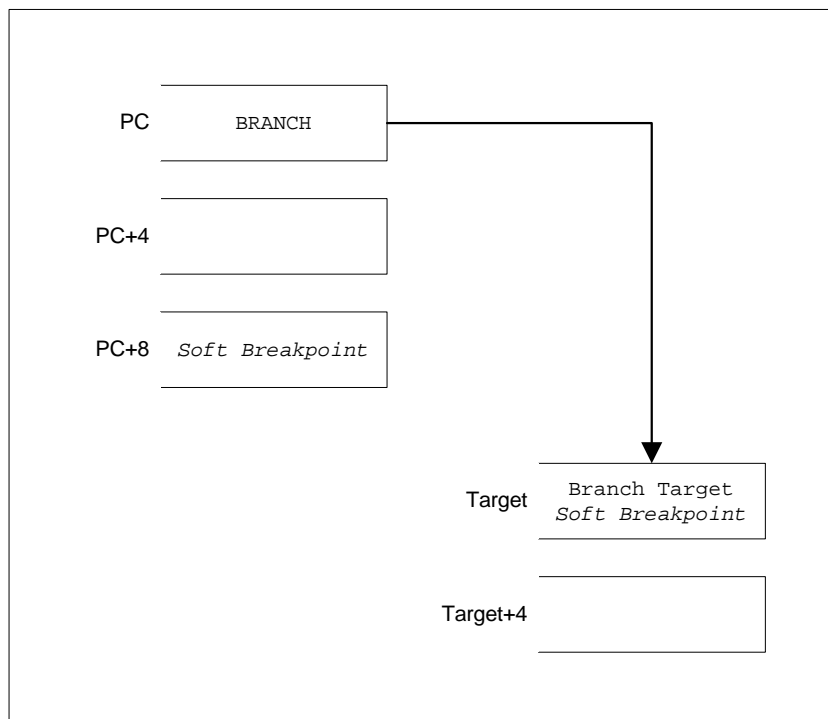
If multiple soft breakpoints are set in the memory, this condition can also be encountered. The case occurs where a soft breakpoint is set 2 instructions after a branch, and another soft breakpoint is set on the branch target. In this case the soft breakpoint value will be executed and the processor will not be stopped. See the following diagram.

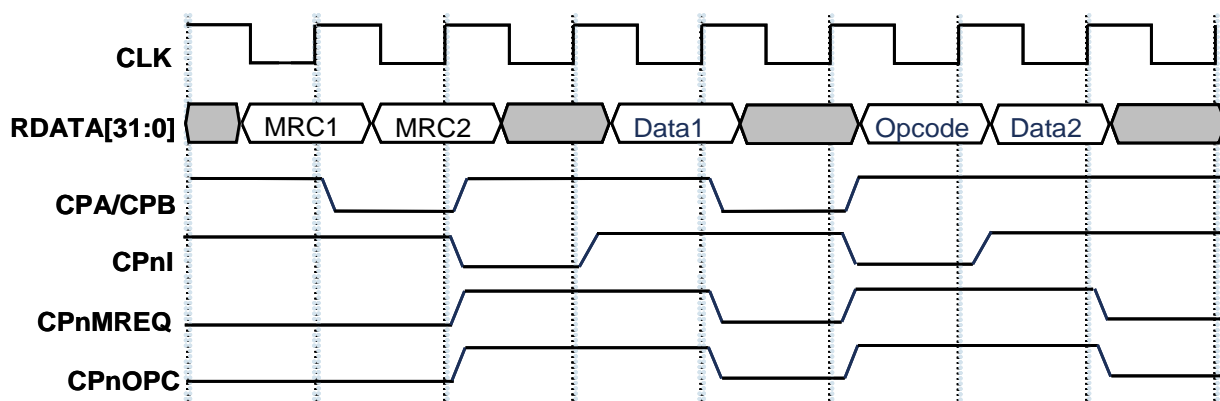
Fig 1: CPA/CPB as driven in the AVS testbench

Figure 1, shows how CPA/CPB are driven in the AVS testbench, causing the bug not to trigger.

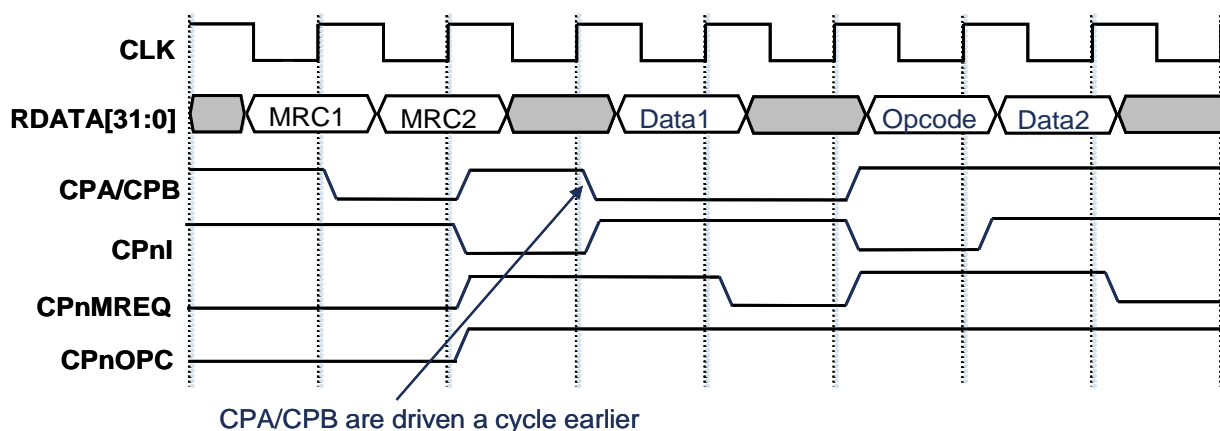
Fig 2: CPA/CPB driven a cycle earlier

The bug is only encountered if the value of <opcode\_1> is set to 3'bx1x and only if CPA/CPB are being driven low by the coprocessor a cycle earlier with respect to CPnOPC/CPnMREQ going low.

Figure 2, shows how the bug is triggered, e.g. when CPA/CPB are driven a cycle earlier by the coprocessor.
