ARM PrimeCell
AMBA 3 HP Matrix (PL301)
Errata Notice

This document contains all errata known at the date of issue in releases up to and including revision r1p2 of PL301 AMBA 3 HP Matrix

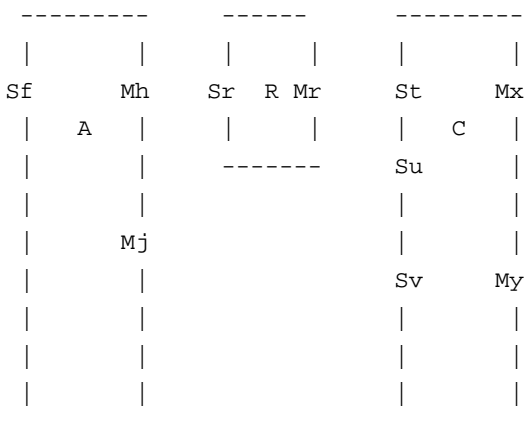
When connecting multiple instances of PL301 in non-trivial ways, it is possible to create a system that can deadlock. This issue is not due to a defect in the PL301 product, but inherent in the flexibility allowed by the AXI protocol.

If there are multiple AXI connections between instances of PL301 and the upstream instance has slave interfaces which allow transactions to more than one master interface at a time then that system could be liable to deadlock due to the relative ordering of AW or AR transfers at their origin and destination.

The following system can exhibit this issue. All slave interfaces use the slave-per-id cyclic scheme:

- (1) Sf->Mh->Sr->Mr->St->Mx
- (2) Sf->Mj->Su->My
- (3) Sv->My
- (4) Sv->Mx

Contact Support for assistance resolving this defect if required.
