CoreLink™  
DDR2 Dynamic Memory Controller (DMC-341r1)  
**Errata Notice**

This document contains all errata known at the date of issue in releases up to and including r1p0 of PL341 AXI DDR2 Dyn Mem Ctrl, and revision r1p1 of DMC-341 AXI DDR2 DYN MEM CTRL

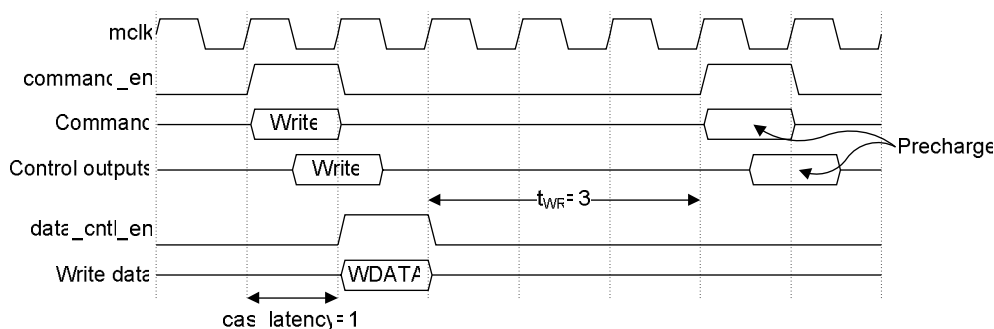
For example the existing diagram Figure 2-19:

The numerical value shown for the timing paramater does not correspond with the timing of the signals shown in the diagrams. In each case, the numerical value should be one higher than the timing shown, and the arrow should be extended to the next rising clock edge.
