ARM PrimeCell®
NAND Flash Memory Controller (PL351)
Errata Notice

This document contains all errata known at the date of issue in releases up to and including revision r2p1 of NAND Flash Memory Controller -3yr Term

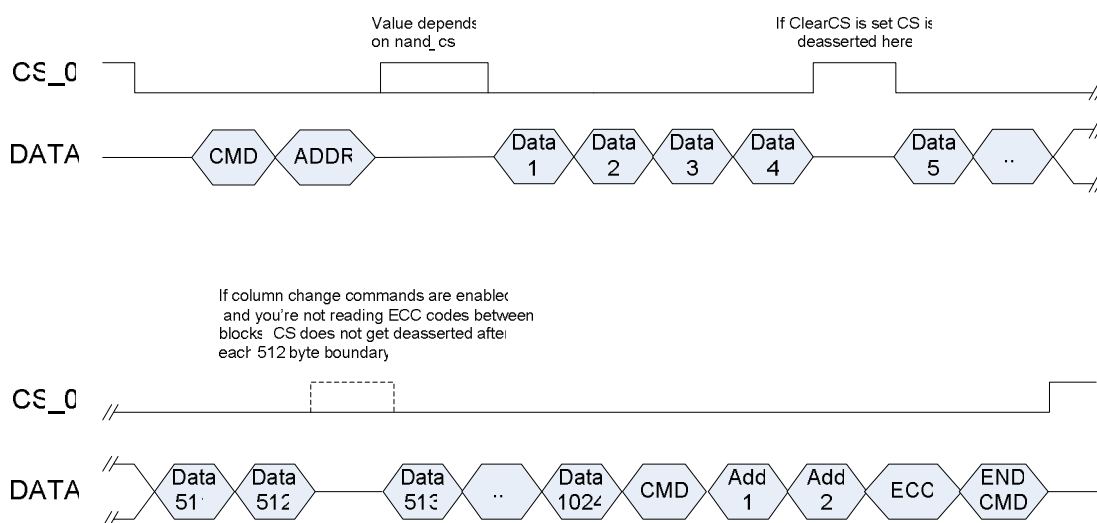
However, in certain modes of operation (specifically when column-change commands are enabled and you are not reading ECC codes between blocks), PL351/353 incorrectly assumes that it is about to perform an operation and cancels the request to ClearCS.

This results in **CS** not being deasserted after the last transfer in a 512 byte block and while **CS** is deasserted the EBI will not be released. The following timing diagram illustrates the **CS** behaviour.

Under the above mentioned conditions, **CS** will not be deasserted. This could result in a deadlock situation if data or code required to create the next transaction is stored through the same EBI.

If ECC is disabled, this problem will not occur.

When using ECC, there are two possible work arounds:

1. Use the ECC block in full command mode for writes, and read ECC codes between blocks for reads.

2. If you are reading or writing more than one 512 byte block, ensure that the data crosses the 512 byte boundary in a single un-interrupted transaction.
