ETM7 Rev 1a Errata

Document number: **ETM7-PRDC-000627 3.0**

Date of Issue: 13 February 2003

This document describes the known errata in the ETM7 Rev 1a design.

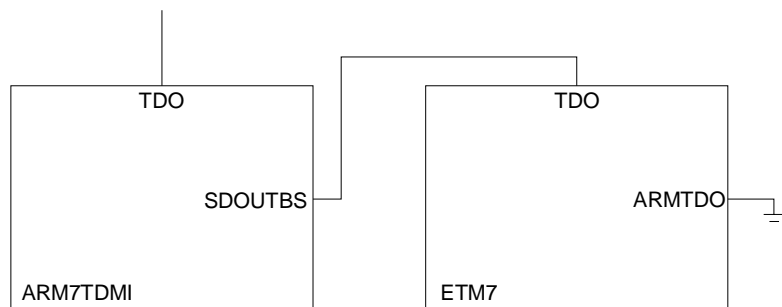
Figure 1: ARM7TDMI TDO connections

When connected to the SDOUTBS input of an ARM core, the ETM TDO output is ignored during Shift-IR. However the ARM7TDMI-S core and derivatives (for example ARM720T Rev 4) do not have an SDOUTBS input, so the ARM7TDMI-S TDO output must be connected to the ARMTDO input of the ETM instead.

The ETM should be connected as described in the ETM7 TRM.

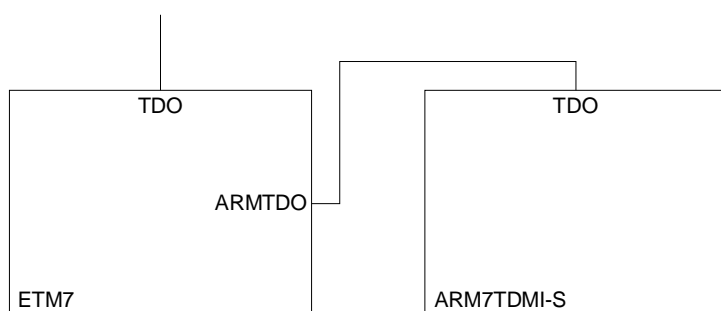
Figure 2: ARM7TDMI-S TDO connections

When the JTAG TAP controller is in the Shift-IR (0xA) state and the BYPASS instruction is selected, serial data is transferred from TDI to TDO through the BYPASS register with a delay of one clock cycle. The instruction register is supposed to be selected as the serial path between DBGTDI and DBGTDO in this situation. If the ETM TDO output is used to connect the TAP controller of another device in series with the ETM/ARM, then during Shift-IR, an undefined instruction can be shifted into the device connected.

This errata can only be observed when the ETM7 is used with an ARM7TDMI-S core, or an ARM7TDMI-S based core such as ARM720T Rev 4.

The device connected in series with the ETM TAP controller but after it in the JTAG scan path will get incorrect instructions if using an ARM7TDMI-S core or derivative (for example ARM720T Rev 4).

- Instead of using BYPASS, use the CLAMP instruction. This causes the ARM7TDMI-S core to behave as if the BYPASS instruction is selected, but causes the ETM7 macrocell to behave as if the INTEST instruction is selected.
- Before using CLAMP, ensure that scan chain 6 has been deselected. This causes the ETM7 macrocell to route the ARM7TDMI-S TDO to its TDO, and in effect selects the core BYPASS register.

- Implement a shadow TAP controller which shares its TDI, TMS, CLK, TCKEN and nTRST inputs with the ETM7 macrocell.
- Implement a multiplexer on the ETM7 and ARM7TDMI-S TDO outputs. When the shadow TAP controller is in BYPASS, select the ARM7TDMI-S TDO output, otherwise select the ETM7 TDO output.
